Boiler tube failures at global chemical manufacturer leads to review of water treatment programmes on site

Importance of partnership approach between supplier and manufacturer is the key to good water treatment results

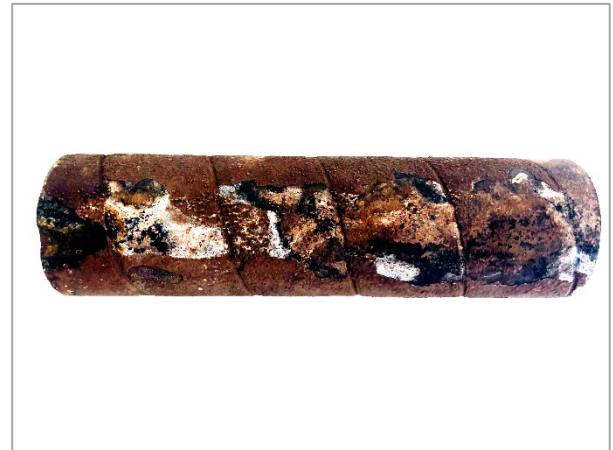
1. Metallurgical examination of the failed boiler tubes showed large areas of corrosion typical of 'under-deposit corrosion'. The deposits were found to be largely iron-based.
2. Condensate pH was found to be acidic (~6.0) and high levels of iron (up to 1 ppm) were also present.
3. Boiler chemicals were being diluted with untreated water, which is not good practice because it introduces hardness into the boiler.
4. Review of operator log sheets showed that chemical treatment residuals in the boiler water were frequently out of the recommended range and chemical dosing was not reliable due to what was suspected as empty chemical tanks and pump failures.
5. Conclusion was that main cause of boiler failure was due to condensate corrosion leading to elevated levels of iron returned the boiler. Secondary factor was poor control of internal boiler treatment programme, both

resulting in deposits and under-deposit corrosion.

Plate 1: Boiler firetube with widespread corrosion.

1. Correct design of new chemical programmes based on actual operating conditions and water chemistry.
2. Installation of new dosing systems for the cooling tower and boiler chemicals, utilizing neat dosing of chemicals and P&ID controllers.
3. Mutually agreed service plan with Visentia personnel visiting site to check the water chemistry and chemical dosing on a fortnightly basis.
4. Addition of a volatile corrosion inhibitor treatment to the condensate system, which had not previously been done.
5. Comprehensive *Legionella* risk management plan put in place to mitigate occupational health and safety concerns associated with biocontrol of the cooling water.

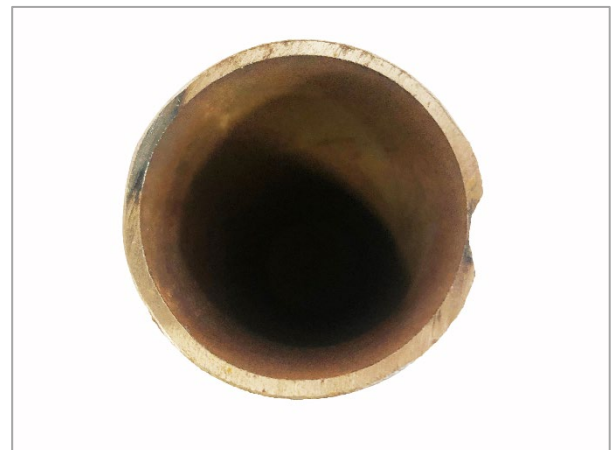
Plate 2: Boiler firetube showing depth of under-deposit corrosion.
