New Zealand fellmongery cleans boiler scale and reduces energy costs

Implementation of boiler water management best practices and use of Visentia's V-GUARD* range of boiler water chemicals is key

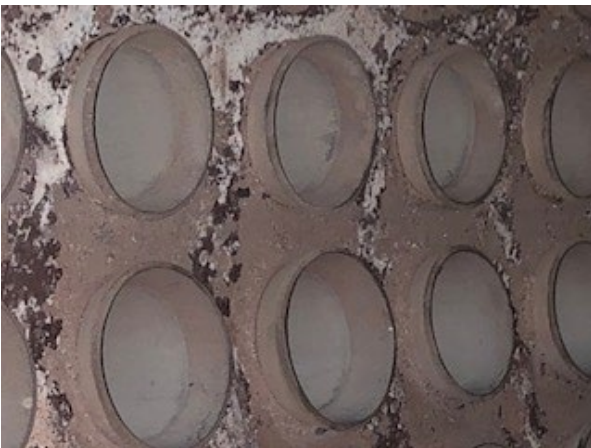
During the annual boiler inspection, a New Zealand fellmongery discovered that they had a heavily fouled boiler. There was a large amount of scale and deposits present on the boiler drums and tubes.

Plate 1: Photograph of mud drum and boiler tubes taken during annual inspection showing the gradual clean-up of the boiler fouling due to use of Visentia V-GUARD internal boiler treatment.

1. Installation of sensors and automation to monitor the condition of the condensate continuously, so that it can be dumped automatically when a contamination slug is detected.
2. Chemical dosing of the boiler using Visentia's V-GUARD internal treatment products to prevent scale and corrosion. Specially formulated to provide robust control of boiler water during feed water quality incidents and to clean-up scaled boilers over time.
3. Application of Visentia's V-COR corrosion inhibitor to the condensate system to reduce return of iron to the boiler.
4. Replacement of softener resin and appropriate preventative maintenance to ensure reliable operation and good quality feedwater makeup.
5. Water treatment chemistry training for boiler water operators.
6. Regular review of boiler water chemistry testing results with Visentia water treatment consultants.

1. A 50% reduction in boiler water chemical costs due to improved feedwater quality to the boiler.
2. Over the following 2 years, the internal boiler condition showed steady improvement in levels of fouling due to V-GUARD programme providing on line cleaning of old scale deposits.
3. A 5% reduction in energy cost due to improved condensate recovery and improved heat transfer.
